Manhole Inspection Summary

Manhole # S17CC2006MH

Insp Date: **8/3/06 8:35 AM**

Location Address: **1904 SULGRAVE AVE**

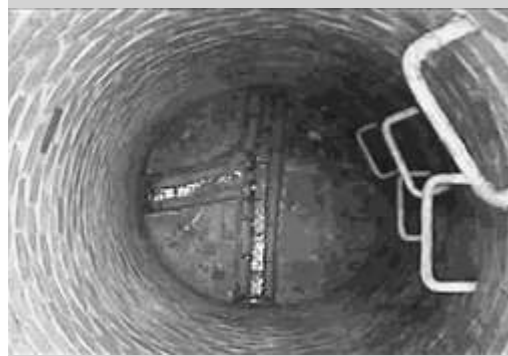
Top View

Comments **The MH is preventing the homeowners from entering their own driveway because it is above grade - damage in the surrounding sidewalk causes their car to hit the MH.**
